Report: 24.021 Bus Shelter – A338 (east bound) at Broken Bridge

Author: Joe Elder, Operations Officer

Date: 30 January 2024

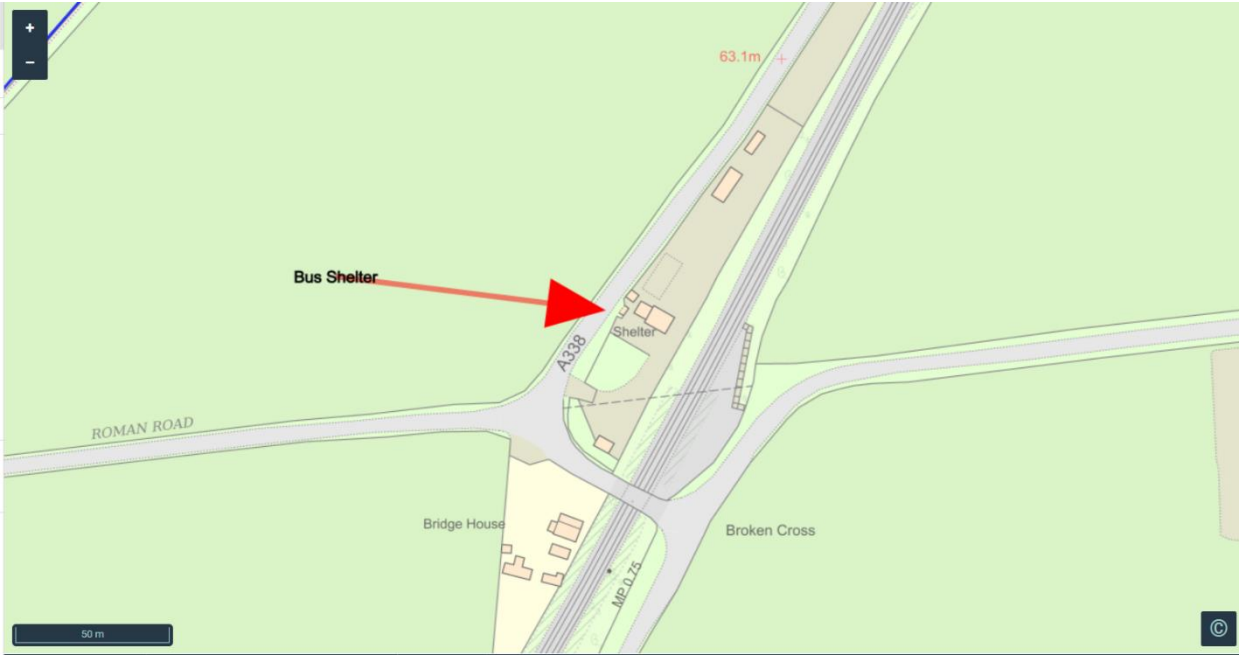
Photo 1.

A report to councillors regarding the status of the bus shelter on the A338 road (east bound) Photo1.

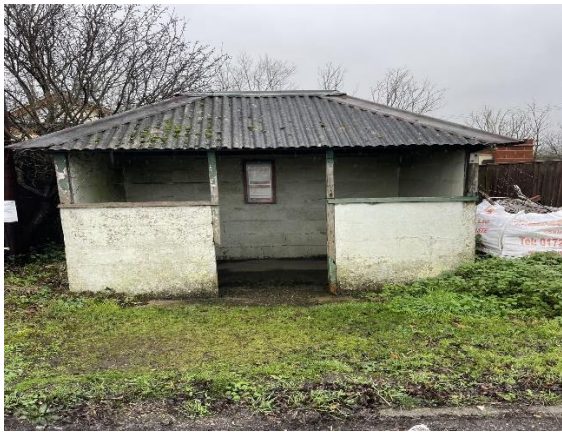
Photo 2.

The shelter is a rendered block brick structure with an asbestos hipped roof. As can be seen from Photo 2, the approach to the shelter has become very overgrown with vegetation. This vegetation has grown over the concrete base that runs from the verge to the shelter. The growth of vegetation presents a slip/trip hazard for passengers boarding/alighting the bus.

- a. Case for or against adoption of the A338 (eastbound) bus shelter
- b. Subject to agreement on adoption, preference for repair or replacement of the shelter
- c. Subject to decision of repair or replacement, financial allocation of funds
- d. Resolution on the actions in relation to the A338 (eastbound) bus shelter

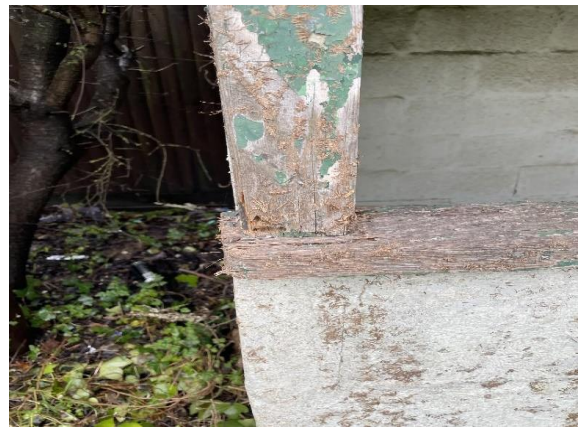
Phot 3

The wooden frame around the entrance and top third of the shelter is rotten and the roof flashing has lifted and buckled along the hips and top ridgeline of the roof photo 3 & 4. The lower left part of the entrance framework is missing and it is believed that this part of the frame work supports the roof structure.

Initial enquiries were made in respect of cost of repair and cost of replacement. Repair to the roof would cost in the region of £5180. The cost for replacement would be in the region of £11,359.
